## Chapter 5 Cherokee Park

Prepared by Andropogon Associates, Philadelphia PA

## Key Master Plan Recommendations for Cherokee Park

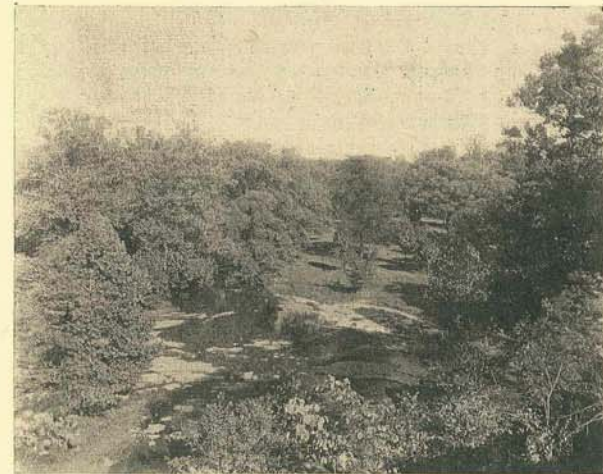
(Top) Exotic invasive shrubs and vines now cloak the woodlands and wall off views through the park. (Andropogon Associates, 1993)

(Bottom) Historic vista across Beargrass Creek and park meadows, c. 1921. (University of Louisville, Photographic Archives, Caulfield & Shook Collection)

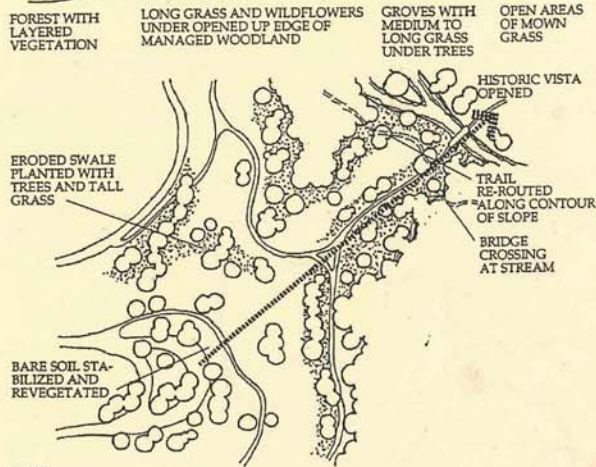
Barringer Hill, Cherokee Park, existing conditions.

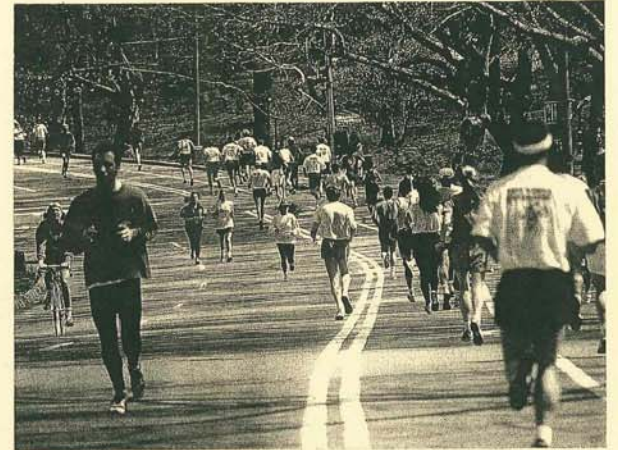
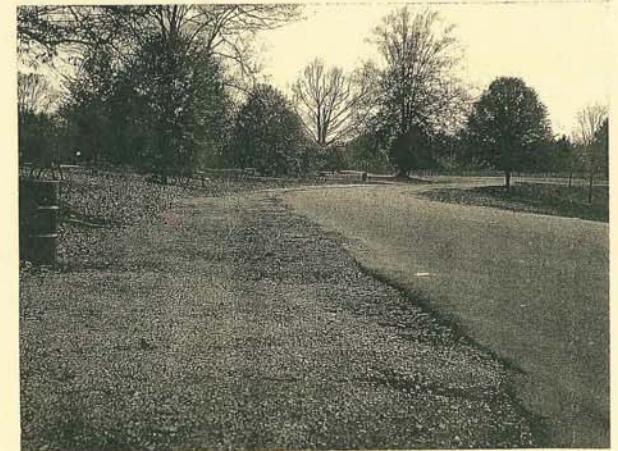
(Top) Park drives in Central Park, New York City, were made one-way, with a multi-use lane for walkers, runners and bicyclists. This became so popular that entire park drives were closed to traffic on weekends. (Central Park Conservancy, Photo by Sarah Cedar Miller)

(Bottom) The unsightly gravel areas for parking in Cherokee Park would be eliminated in the proposed plan, with paved lay-by parking bays occurring at destination areas and smaller wayside stops. (Andropogon Associates, 1993)

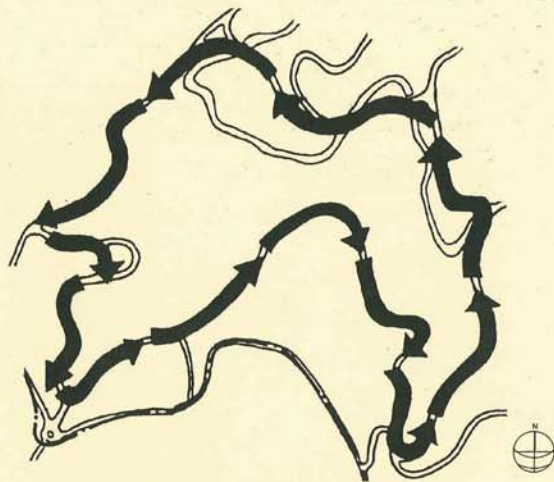
The Scenic Loop is a one-way loop, counterclockwise, from the Eastern Parkway entrance to Hogan's Fountain, down the Dingle and along Beargrass Creek, and up to Barringer Hill.

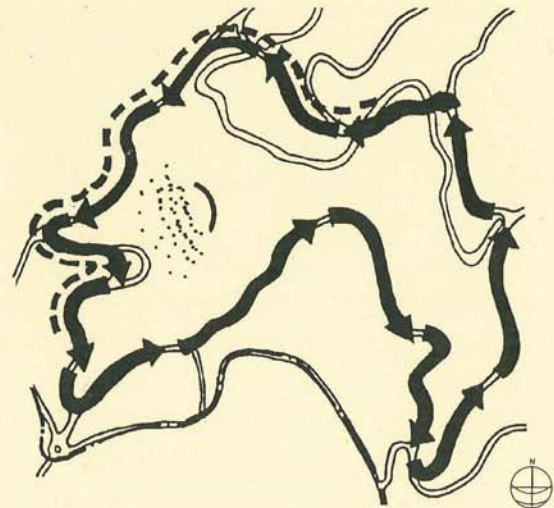
For special performances at Barringer Hill, the multi-use lane on the Scenic Loop could accommodate parallel parking so that spectators could walk to the hill, which would serve as a natural amphitheater for events staged in the lower meadow.

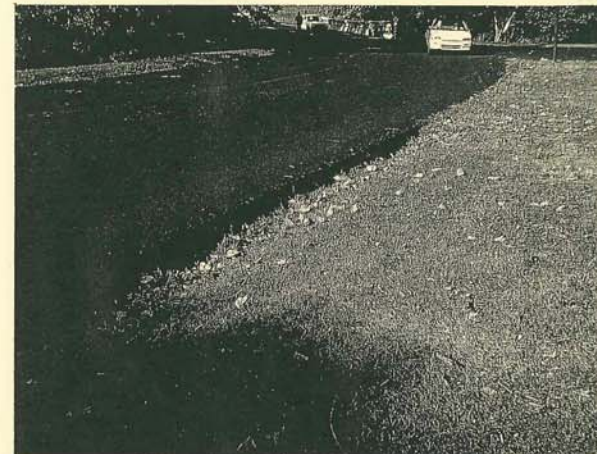
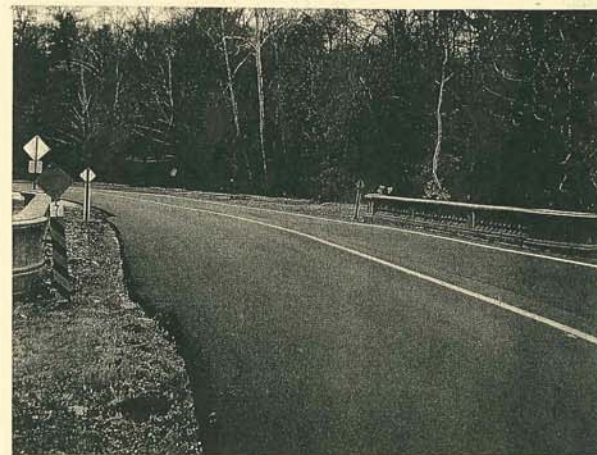
(Top) The repeated repaving of Cherokee Park's drives has resulted in a raised, unsafe roadway edge. These drive edges require stabilization and reconstruction of drainage infrastructure, so that they will be safe and functional. (Andropogon Associates, 1993)

(Bottom) The raised pavement near bridges has contributed to stormwater runoff damaging the bridge abutments and bridge railings. (Andropogon Associates, 1993)

The layers of asphalt on park drives from repeated repaving projects is now out of character with the original design intentions of these scenic drives. The original crowned roadway section, with flush grass swales, giving the appearance of roads imprinted in the landscape, has been significantly altered, with widened areas of roadway and pavement edges up to 10 inches above grade, causing gullies and unsafe conditions for park users and drivers alike. Given that most of the inlets and culverts are nonfunctional, due to settlement and siltation, the resulting deterioration of road edges and adjacent woodlands is becoming a serious erosion problem. The historic bridges along the scenic Beargrass Creek drive are also in need of repair. The layers of asphalt on the drive, coupled with the frequent flooding of the creek, have seriously eroded the banks adjacent to bridge abutments.

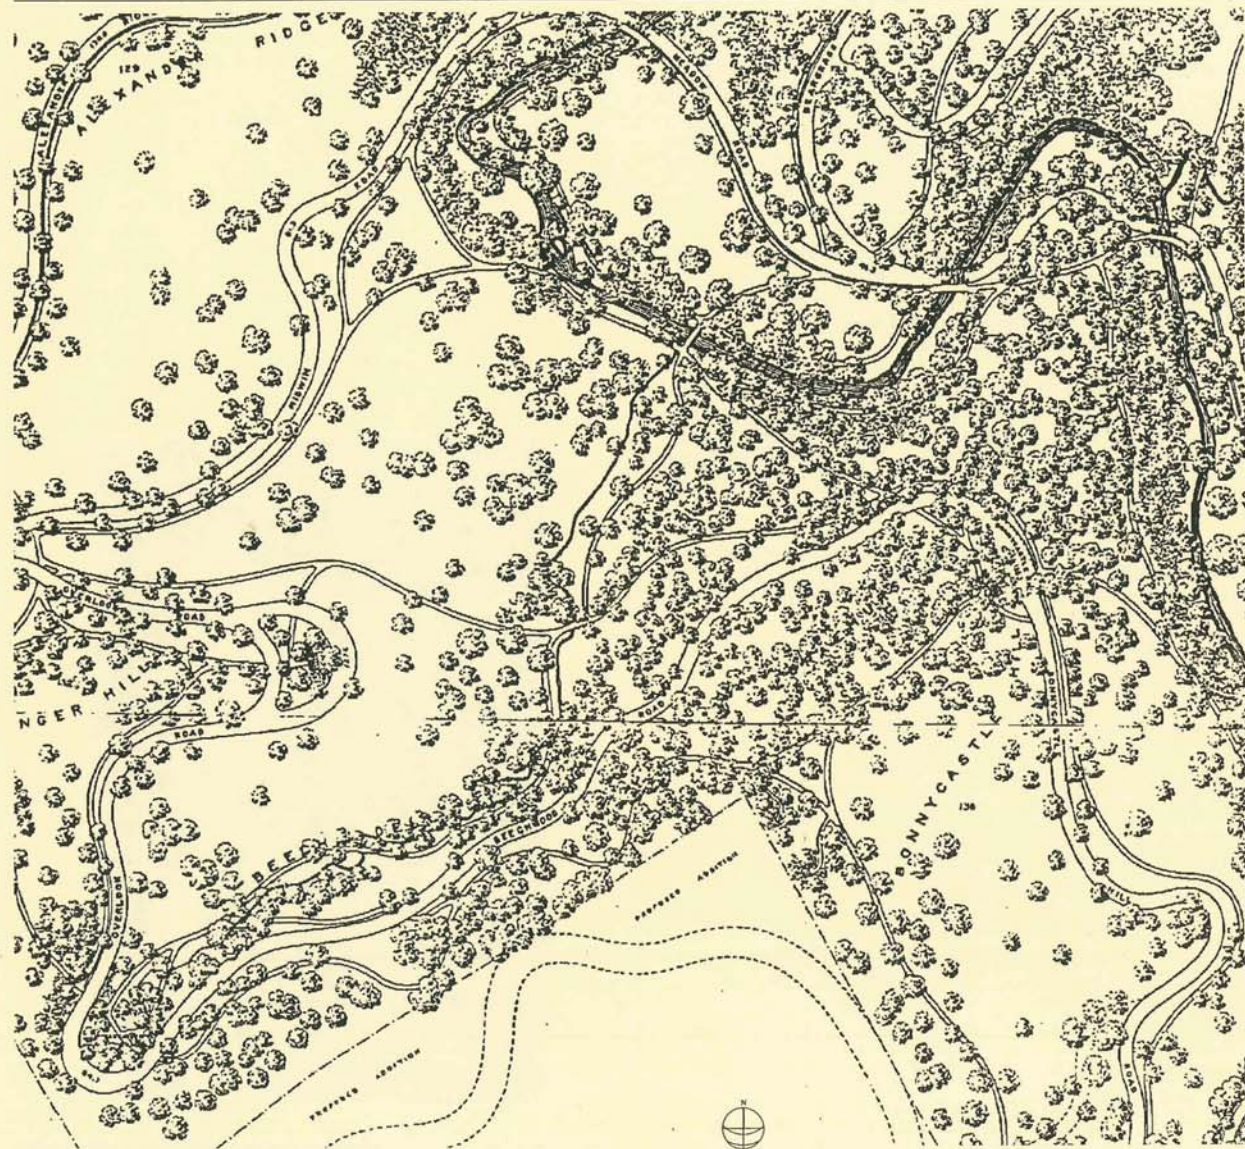
General Plan for Cherokee Park, Louisville, Kentucky, December 1897, by F.L. & J.C. Olmsted, Landscape Architects. (FLONHS)

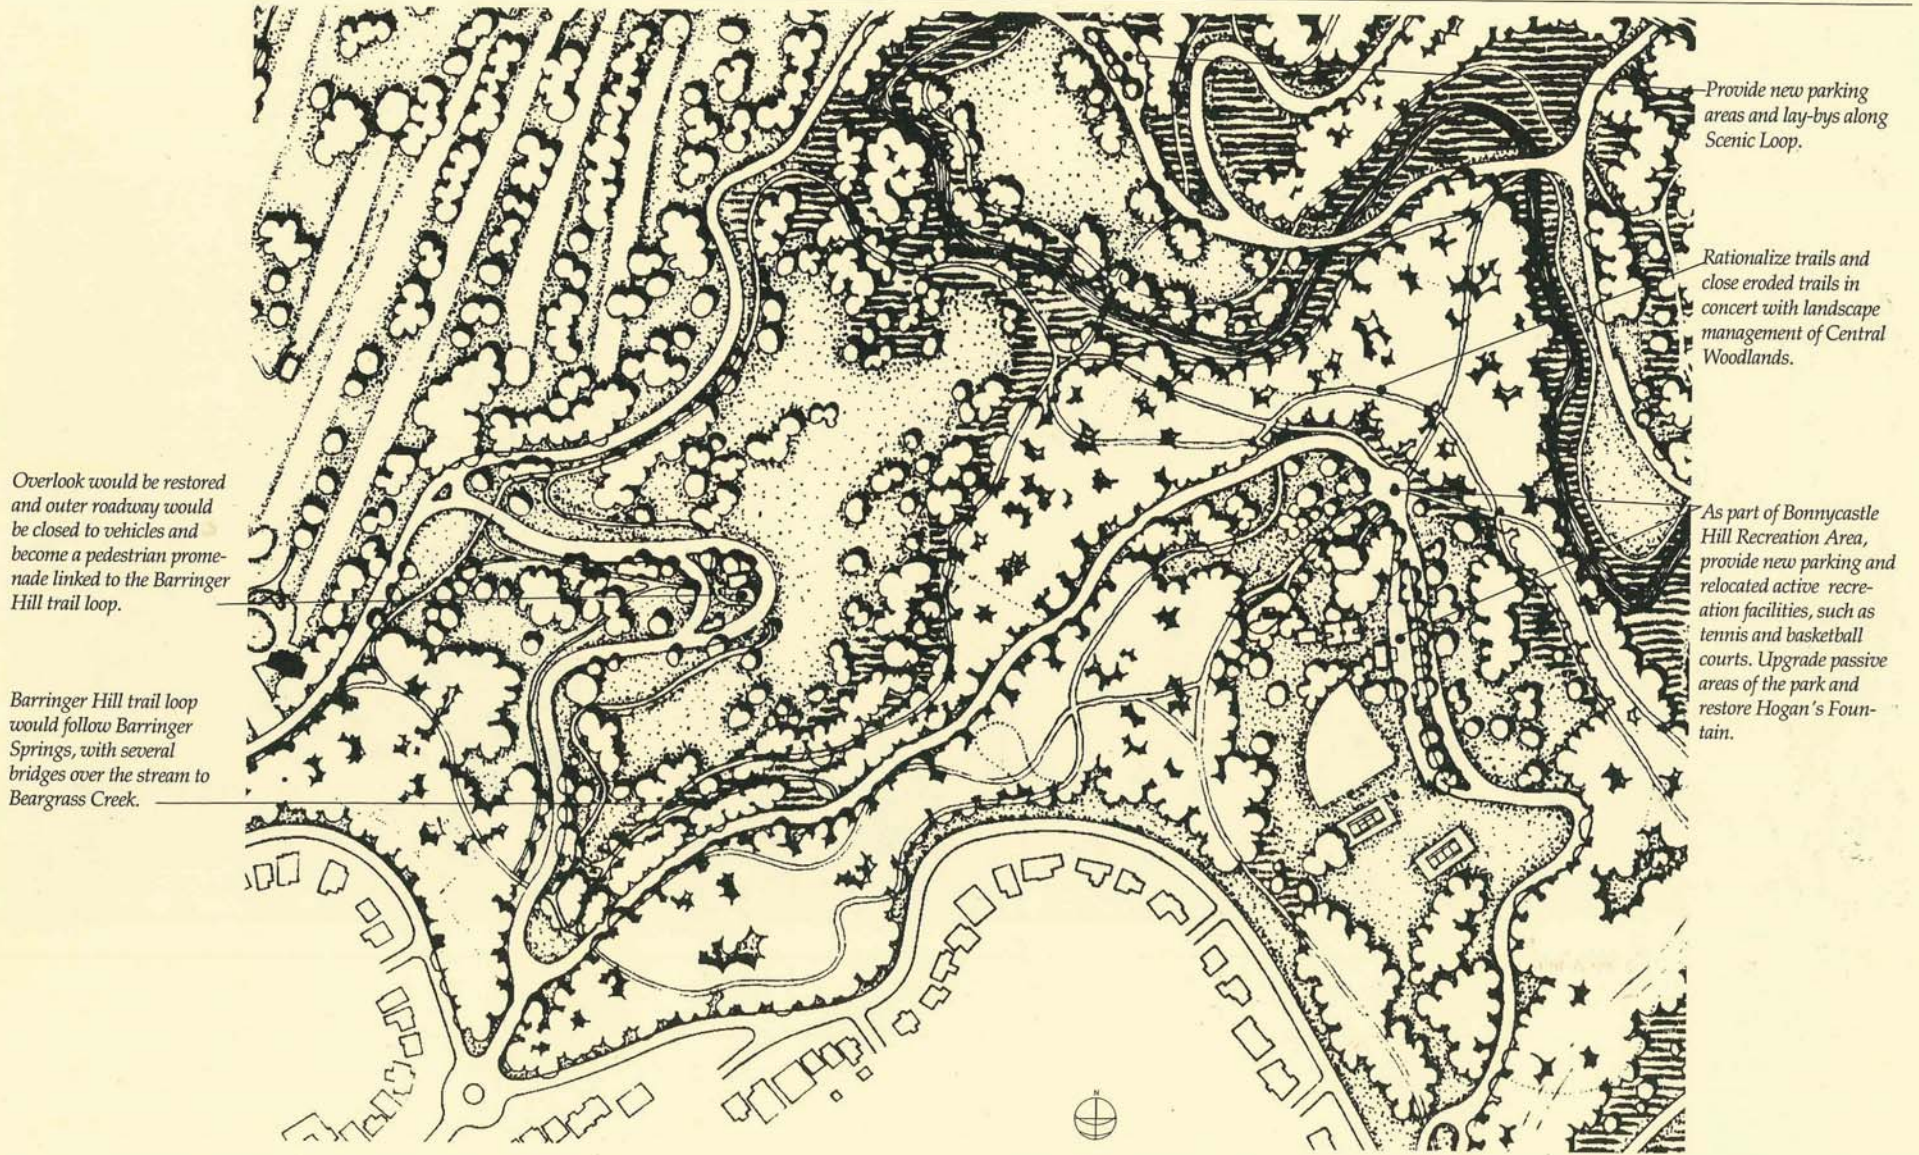
Illustrative Master Plan for Cherokee Park, showing renewal of Barringer Hill, Central Woodlands and Bonnycastle Hill.

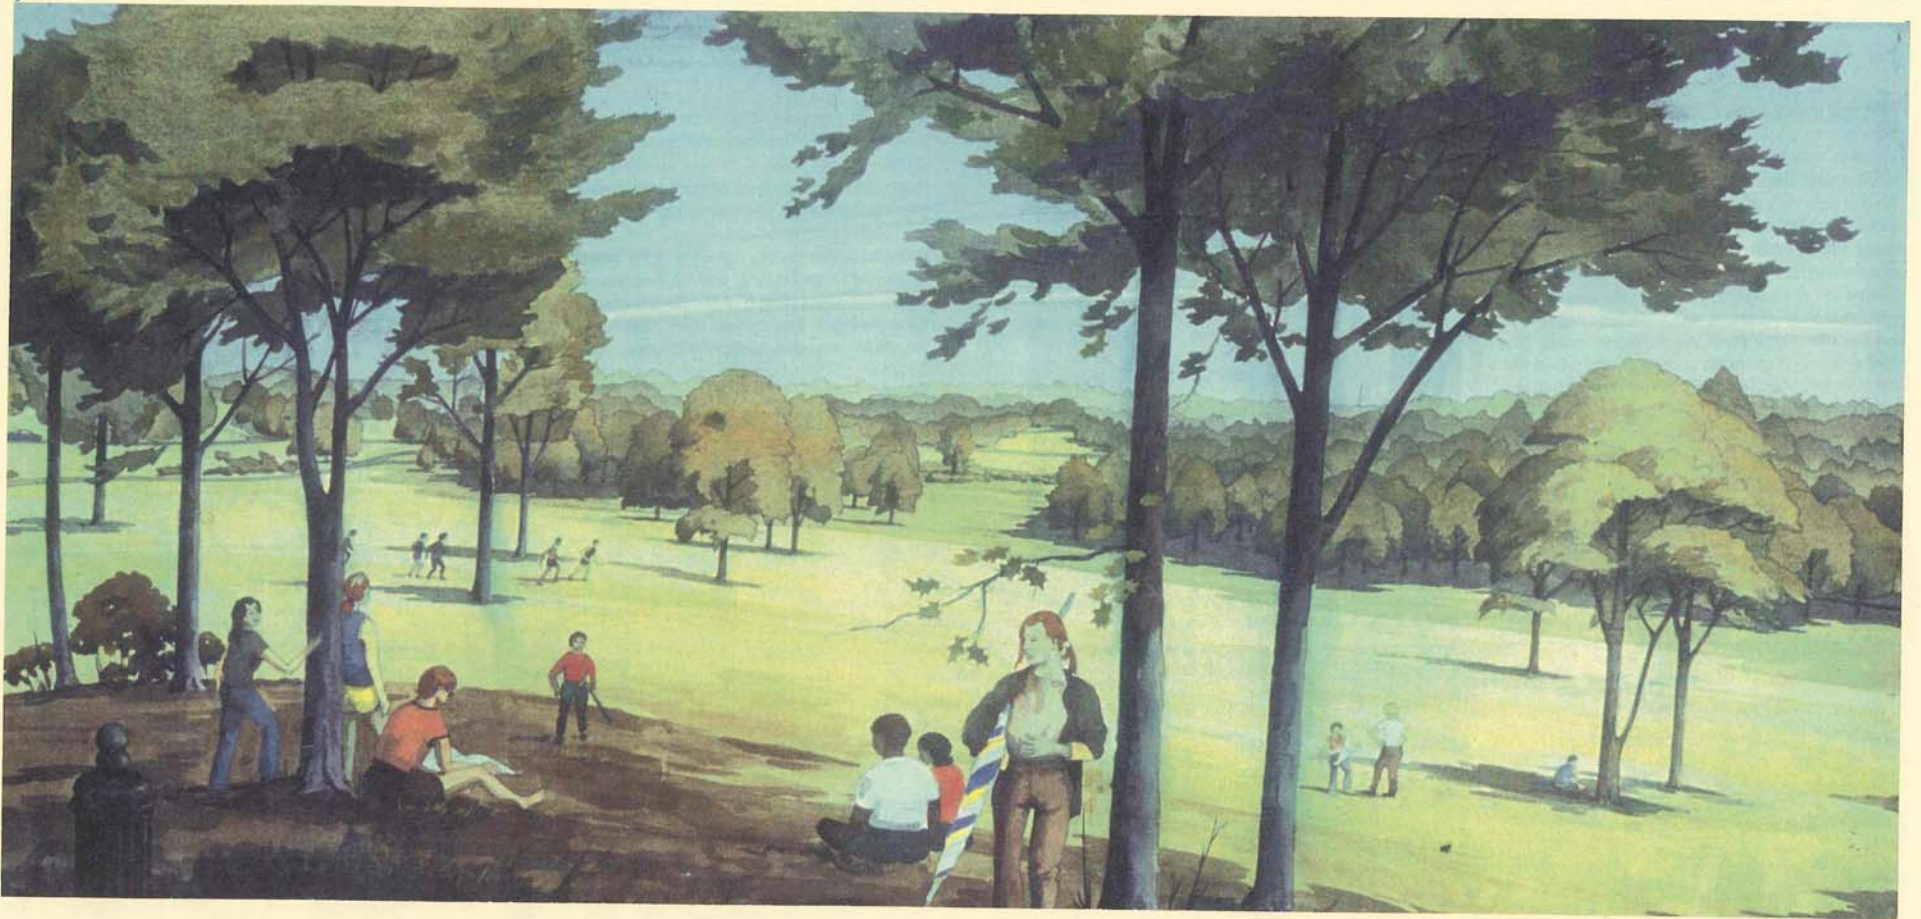
*View of proposed renewal of Barringer Hill vista, including the installation of the Great Groves of Kentucky, woodland paths and woodland clearance and removal of exotic invasive shrubs, trees and vines. (Rendering by Colin Franklin, Andropogon Associates, 1993)*

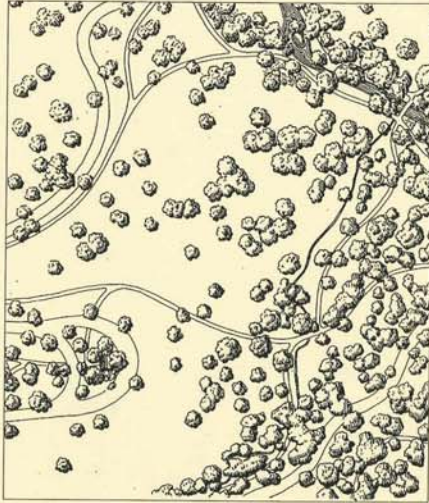
Historic Design Intent: Plan of Barringer Hill, as proposed in F.L. & J.C. Olmsted's General Plan of 1897

Original conditions of the site, from an 1891 survey, show a mature beech woods, with black walnut, sycamore and elm, and a largely open understory. Barringer Hill was in pasture, with a few hedgerows of black locust, cherry and ash. Olmsted's proposed park plan of 1897 shows the design intent of a vista through the woods from the overlook to the creek and hillside beyond. Groves of mature trees overlap the edges of the vista, with views under and through the groves as well as over the tops of tree canopies. Many trees had enormous canopies and were underlain with carpets of wildflowers and a rich woodland groundcover.

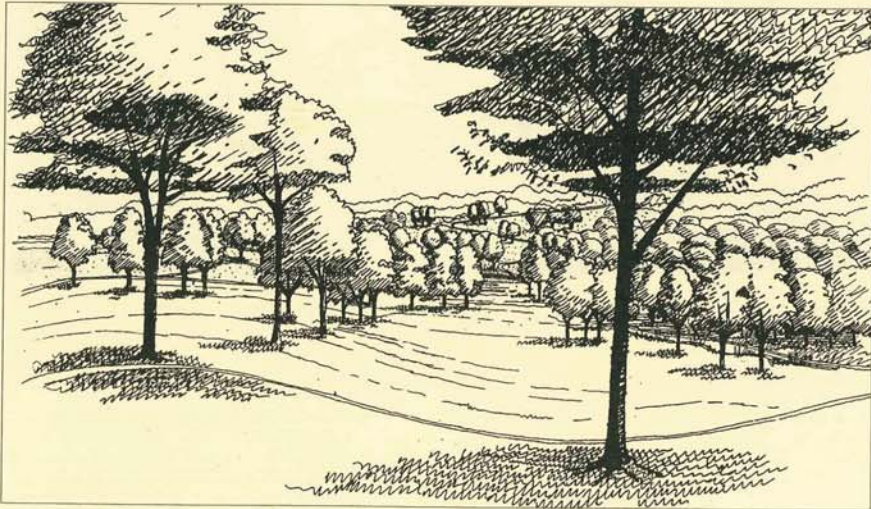
Historic Design Intent: Barringer Hill Vista, as proposed in F.L. & J.C. Olmsted's General Plan of 1897

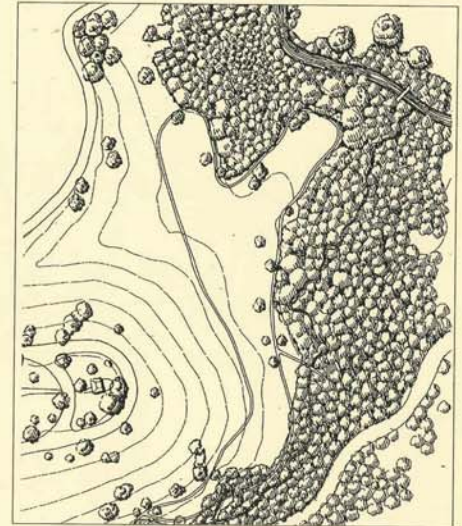
Current Conditions: Plan of Barringer Hill, 1994

The 1974 tornado felled over two thousand trees in Cherokee Park. Barringer Hill in particular was devastated—the tornado cleared a swath on both sides of Beargrass Creek. Many of the mature trees were completely uprooted. The sudden loss of canopy reduced the forest cover substantially and fostered the spread of invasive, non-native species. The twenty years of unmanaged understory growth has resulted in a dense thicket of vegetation that blocks the historic vista from the hill above. The mature trees have been replaced by stands of younger, relatively even-aged trees, with an understory clogged with invasive shrubs and vines.

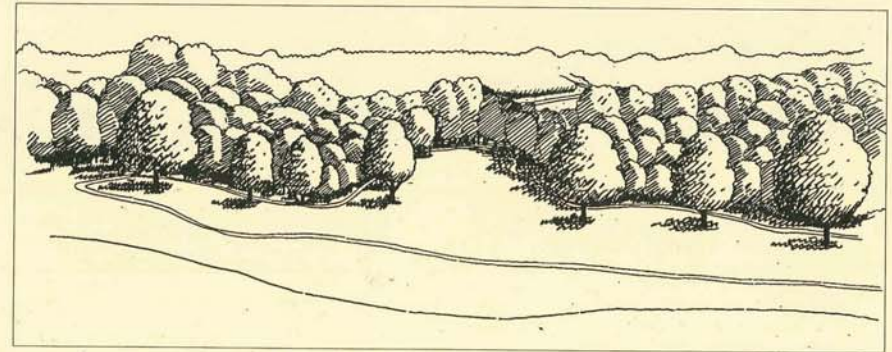
Current Conditions: 1994 Barringer Hill Vista, with vista blocked by trees, shrubs and vines

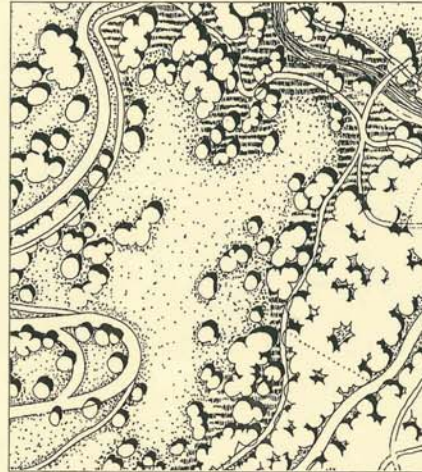
The plan shows the proposed scenario of landscape cover types that is the overall goal of landscape management at Barringer Hill. An open woodland cover type is proposed for the present dense woodland thickets; a savannah of long grasses and tree groves is proposed for the central historic vista; and a greensward of mixed forbs and grasses is proposed for the open hillside.

Proposed Renewal: Plan of Barringer Hill

The primary objective is to restore the spatial character of the open woodlands that Olmsted retained as part of the 1897 General Plan. The chief task is the removal of invasive shrubs, vines and trees that presently form a dense green wall between the forest and the meadow. Removals will be done incrementally and by hand, beginning with vines and shrubs and progressing to young trees, with follow-up work to favor wildflower and woodland groundcover development.

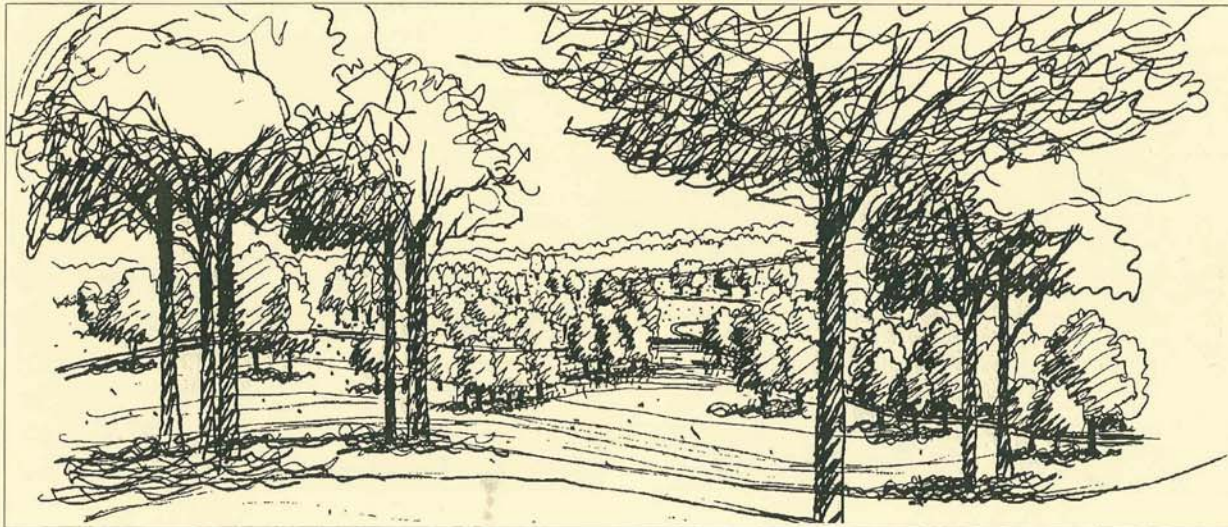
Proposed Renewal: The historic vista and woodland renewal for Barringer Hill, 1994 conceptual sketch

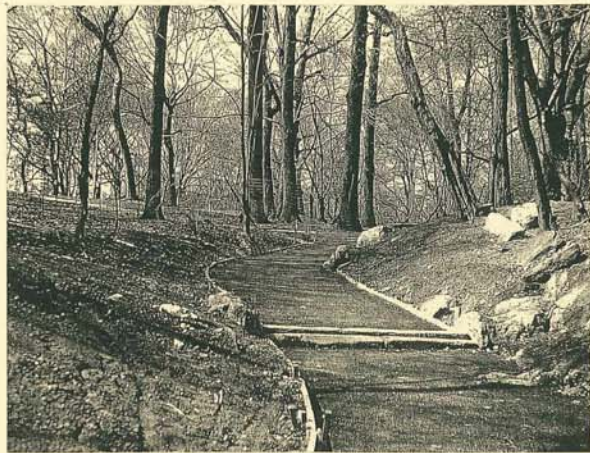
Woodland path restoration in Central Park's North Woods included drainage infrastructure and stabilization of adjacent woodland slopes which had been badly eroded and trampled. (Andropogon Associates, 1993)

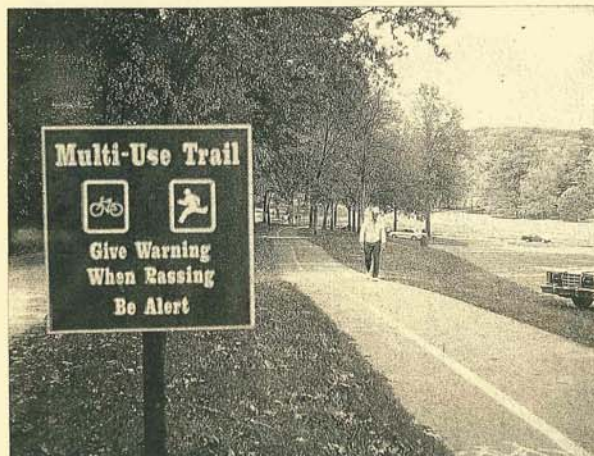
A paved multi-use path at Valley Forge National Historical Park was initially constructed with an 8-foot width, but then became so popular that striping and warning signs had to be installed. (Andropogon Associates, 1993)

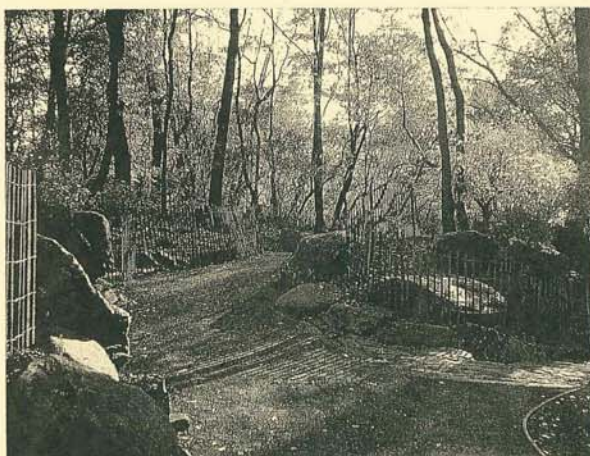
Temporary fencing was installed along several woodland paths in Central Park's North Woods, to notify park users of closed-off "rogue" trails and to allow the woodland stabilization plantings to establish themselves. (Andropogon Associates, 1993)

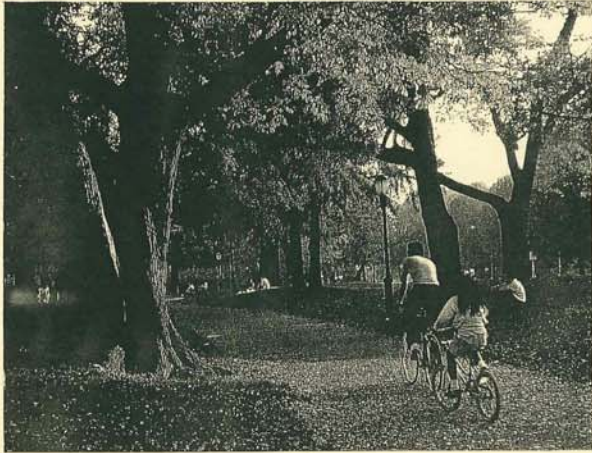
Paved multi-use path through open parkland groves of Prospect Park has become a popular route for families and walkers. (Central Park Conservancy. Photo by Sarah Cedar Miller)

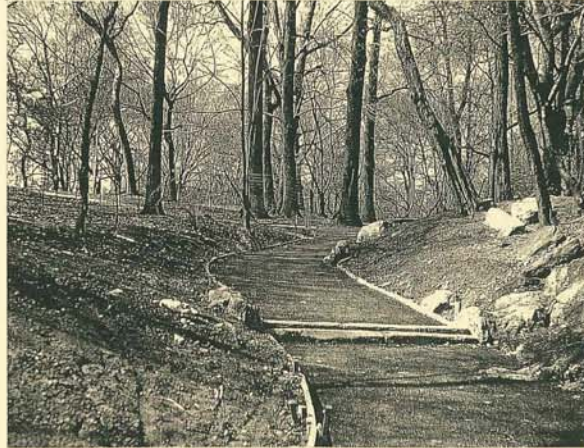
Woodland path restoration in Central Park's North Woods included drainage infrastructure and stabilization of adjacent woodland slopes which had been badly eroded and trampled. (Andropogon Associates, 1993)

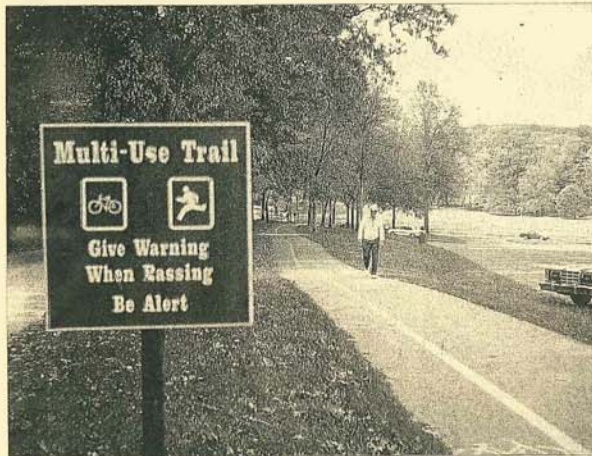
A paved multi-use path at Valley Forge National Historical Park was initially constructed with an 8-foot width, but then became so popular that striping and warning signs had to be installed. (Andropogon Associates, 1993)

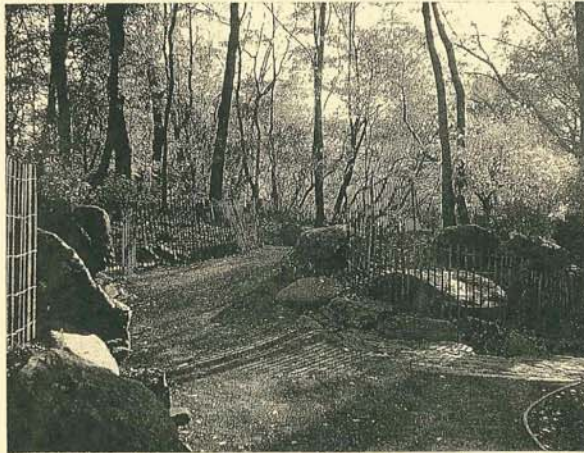
Temporary fencing was installed along several woodland paths in Central Park's North Woods, to notify park users of closed-off "rogue" trails and to allow the woodland stabilization plantings to establish themselves. (Andropogon Associates, 1993)

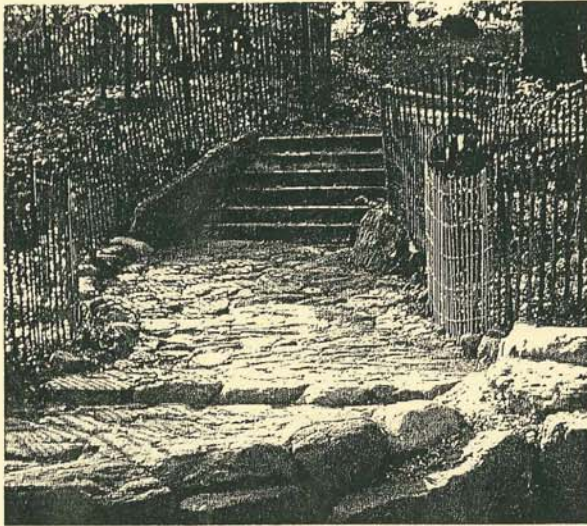
In several areas of Central Park's North Woods, stone steps in the woodlands were reconstructed. (Andropogon Associates, 1993)

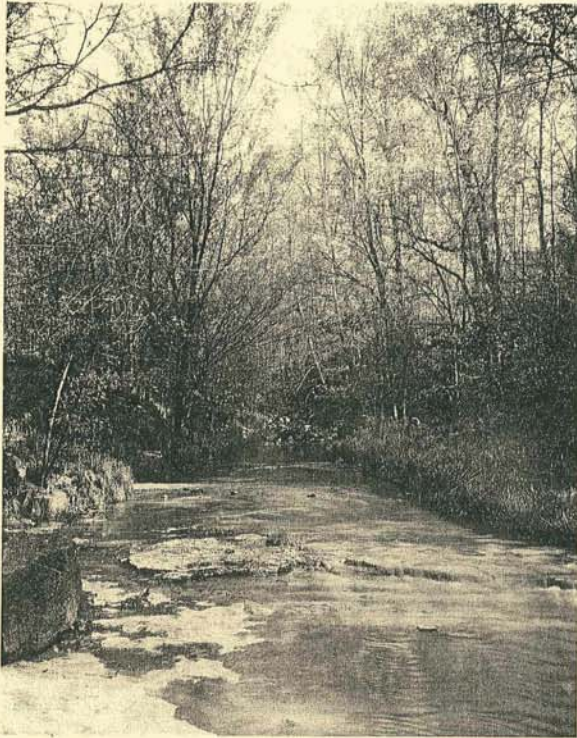
Historic view of Beargrass Creek, showing greenward edge and pools and riffles in the stream course, which have now largely disappeared. (University of Louisville, Photographic Archives, R. G. Potter Collection)

Beargrass Creek valley is the centerpiece of the park. Several historic views of Beargrass Creek show different areas at varied points in time. These views show the historic form of the creek banks, gently sloping to the water, generally with trees and turf along the margins and occasionally some shrubs or herbaceous plants. The many creek crossings were spanned by ornamental bridges. These decorative bridges, often donated to the park, were developed primarily in the 1920s to replace earlier less elaborate bridges. Olmsted office plans also show the planting of the bridges with plant materials that blended with those already present on the creek banks.

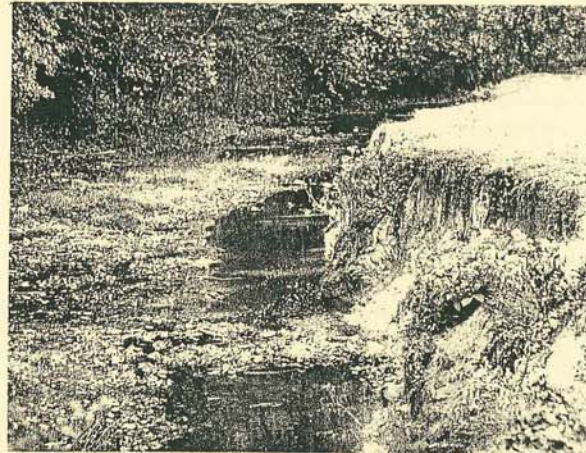
(Top) View of existing Beargrass Creek, with collapsing streambanks and turf edges which do little to stabilize banks. (Andropogon Associates, 1993)

The Beargrass Creek valley today is a landscape of steep, unstable creek banks, cut away over time and held in place by the partially exposed root systems of mature trees. In many areas the creek banks support only meager vegetation. The bridges are showing signs of structural deterioration and undercutting. Storm events bring increasingly large water flows through the Beargrass Creek water system.

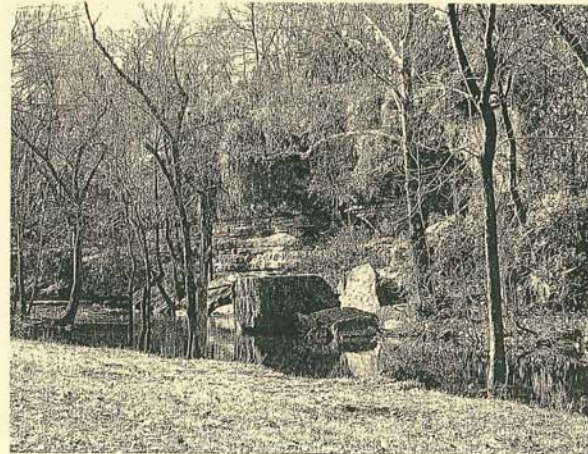
(Bottom) View of Big Rock, which could also benefit from repair of eroded and trampled areas, streambank stabilization and new stabilized paths. (Andropogon Associates, 1993)

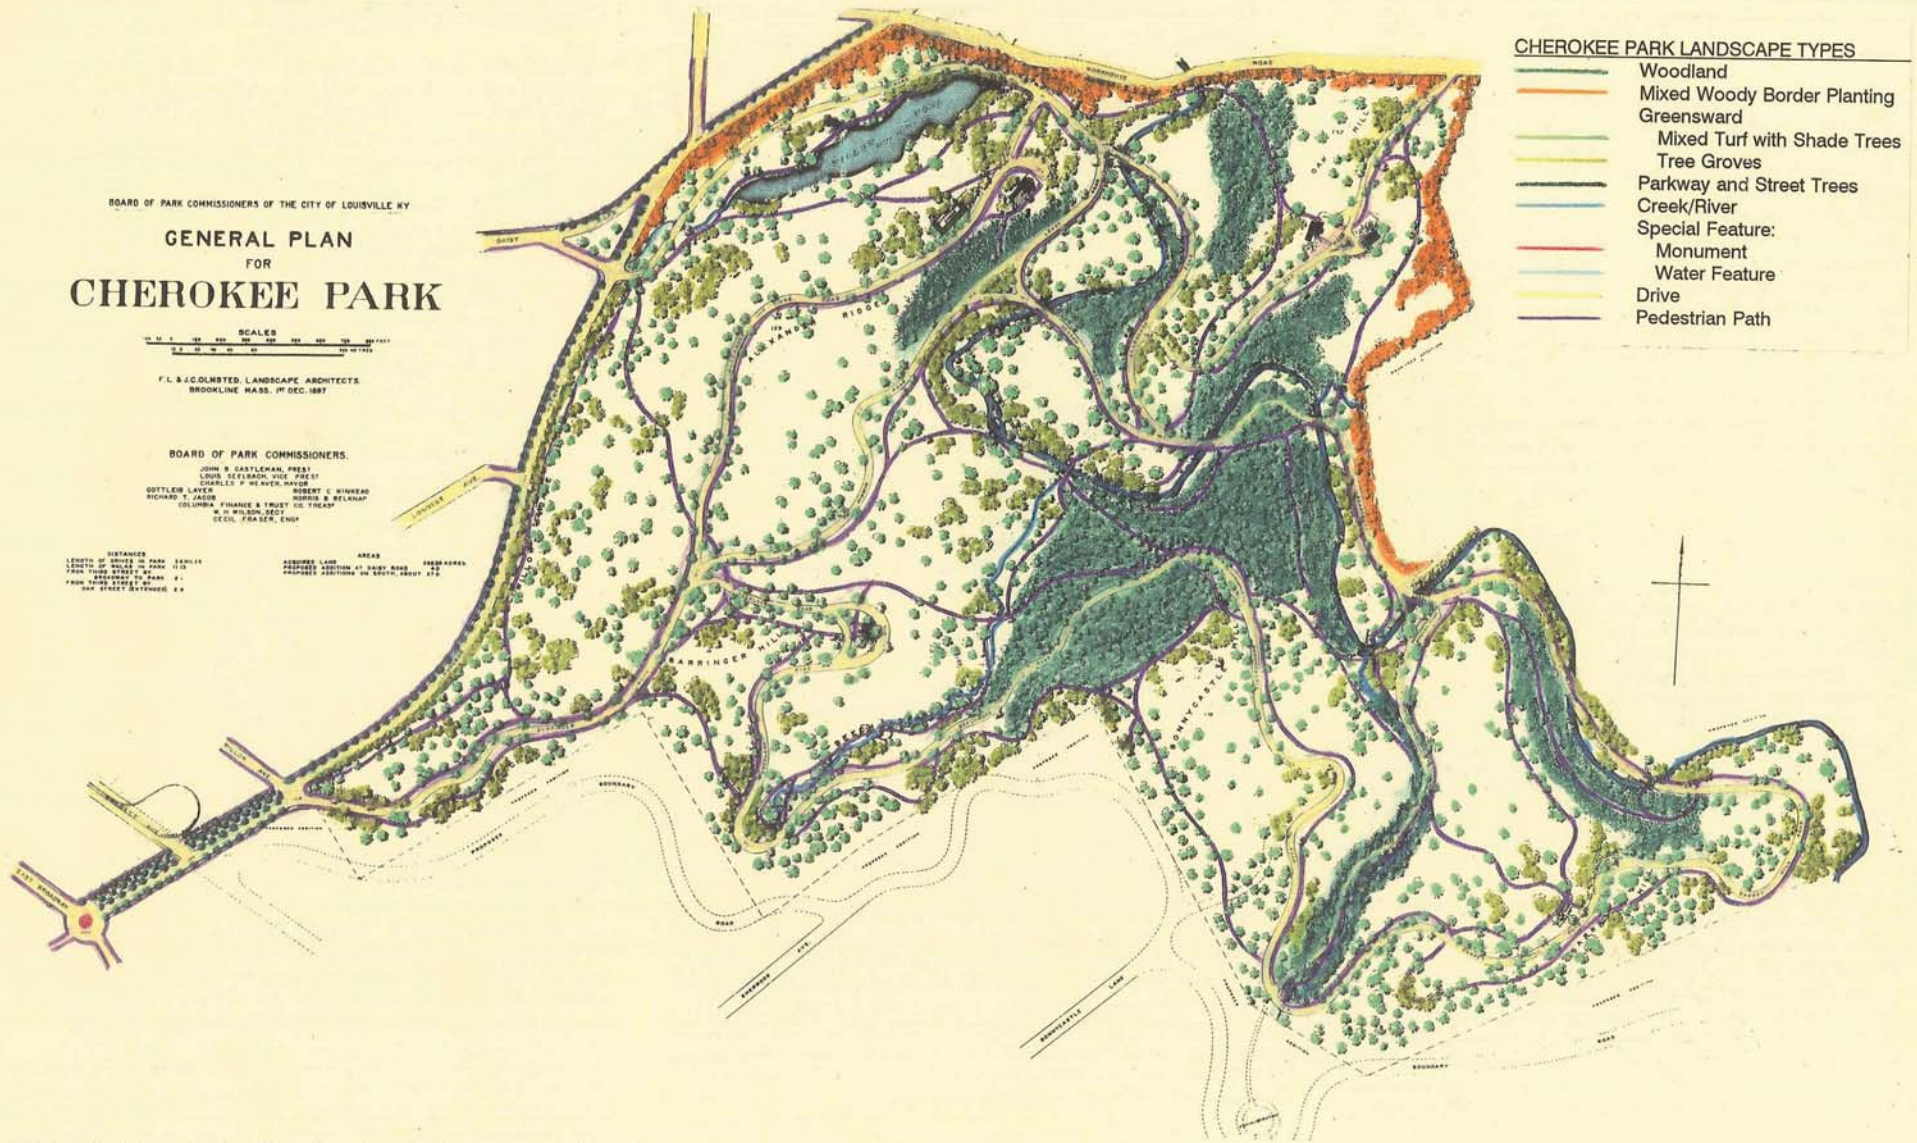
1. Cherokee Park Historic Landscape Types Plan, color coding of vegetation types and circulation, prepared by Landscapes, 1993, overlaid on General Plan for Cherokee Park, Louisville, Kentucky, December 1897, by F.L. & J.C. Olmsted, Landscape Architects. (FLONHS)

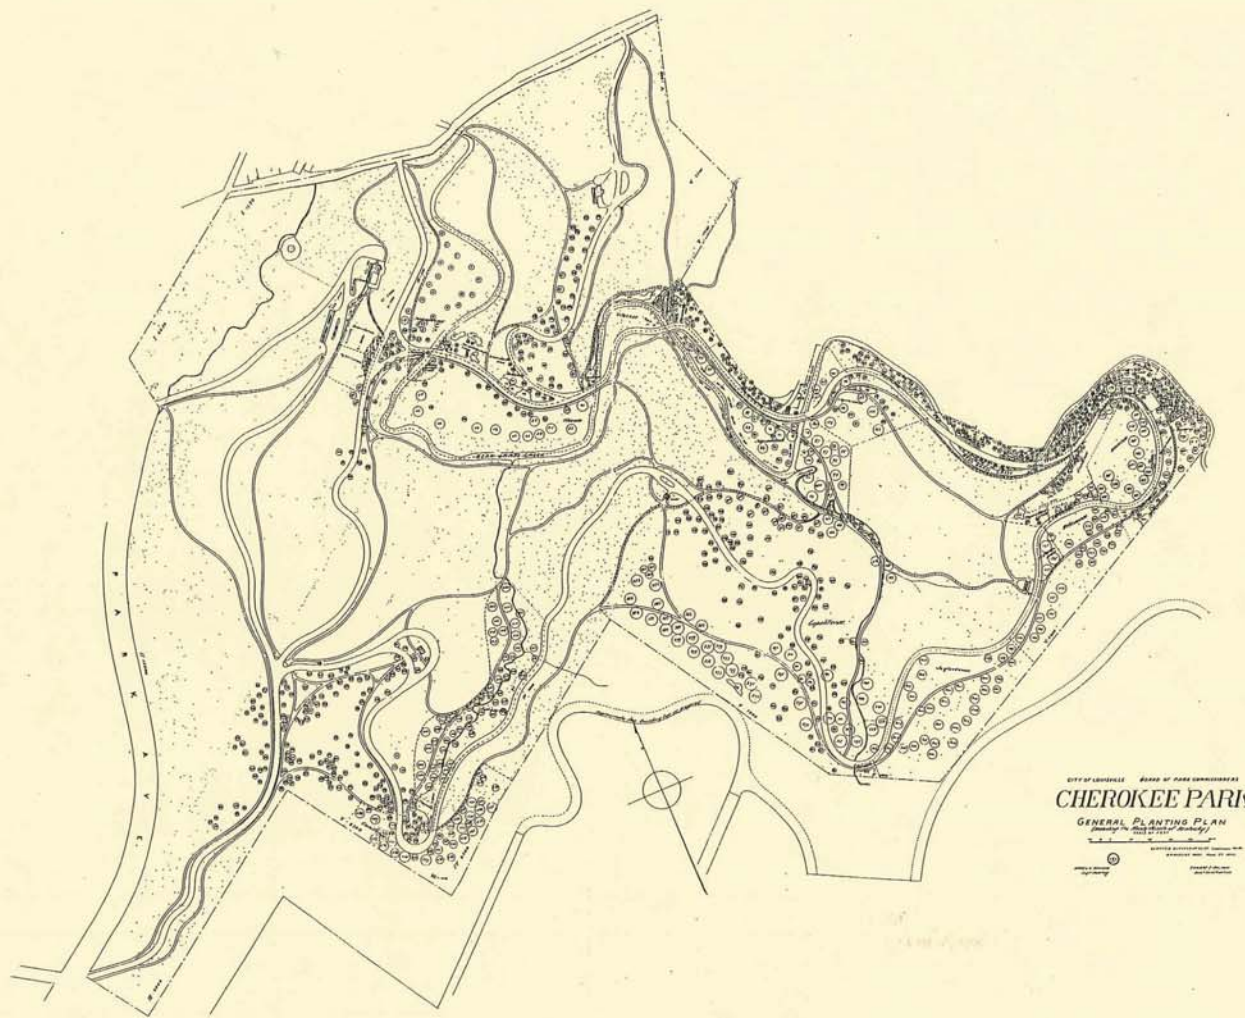
2. General Planting Plan for Cherokee Park, Louisville, Kentucky, Olmsted, Olmsted & Eliot, Landscape Architects, March 3, 1896, includes the Woody Plants of Kentucky. (FLOHNS)

The vehicular movements, parking and understanding of the park as a driving experience require planning and resolution. The pedestrian, bridle and mountain bicycle path use needs to be made compatible or separate. The Beargrass Creek banks require stabilization and enrichment planting. The vegetation of the park slopes needs to be reopened, with mature trees cared for and new planting carried out to reshape the landscape applying the Olmsted design intent. The remains of the Woody Plants of Kentucky collection need to be discovered and an approach to the recapture of this regional resource developed. The extensive Olmsted planting plans for Cherokee Park provide a detailed basis for the reinstatement of the Cherokee Park landscape.

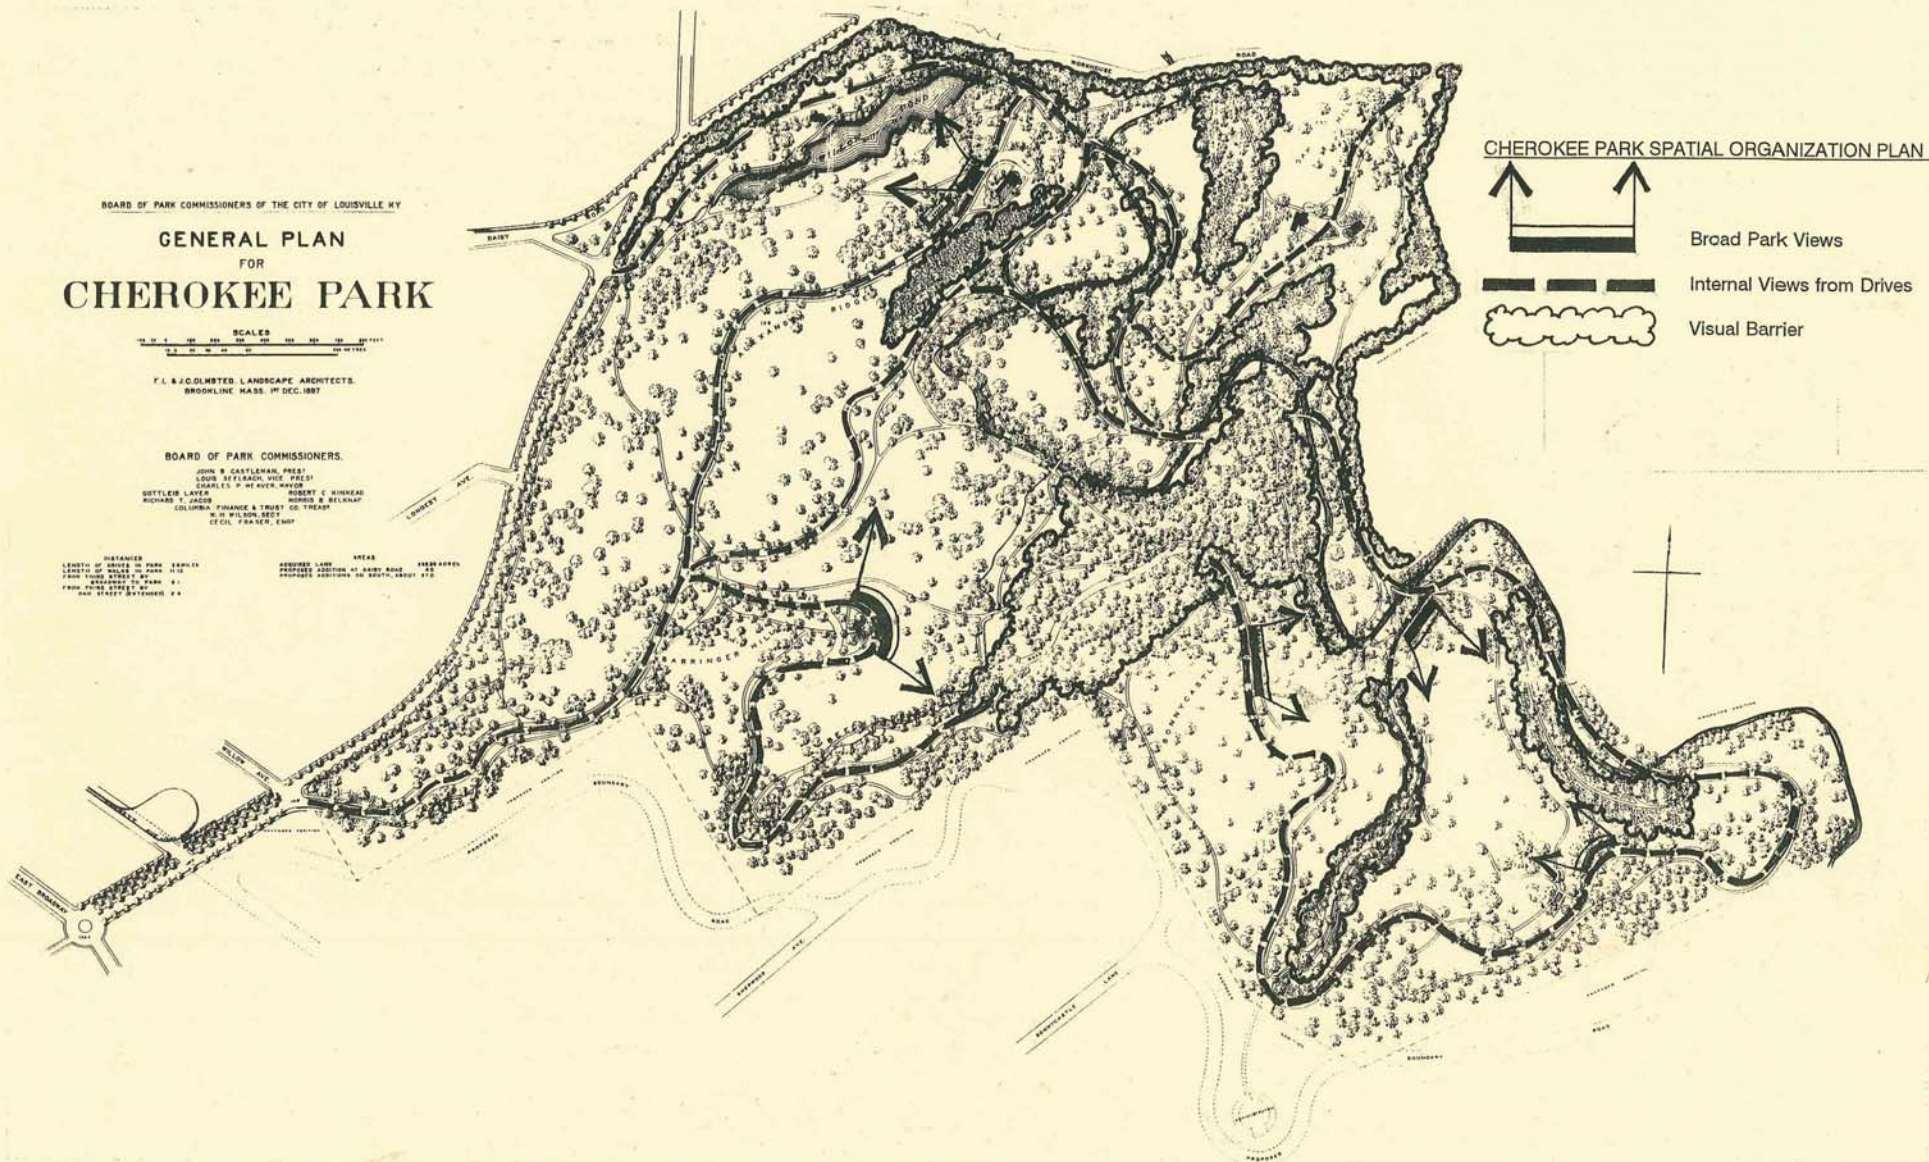
4. Spatial Organization Plan, prepared by Landscapes, 1993, overlaid on 1897 General Plan of Cherokee Park, Louisville, Kentucky. (FLONHS)
