## Chapter 5 Cherokee Park

Prepared by Andropogon Associates, Philadelphia PA

## Key Master Plan Recommendations for Cherokee Park

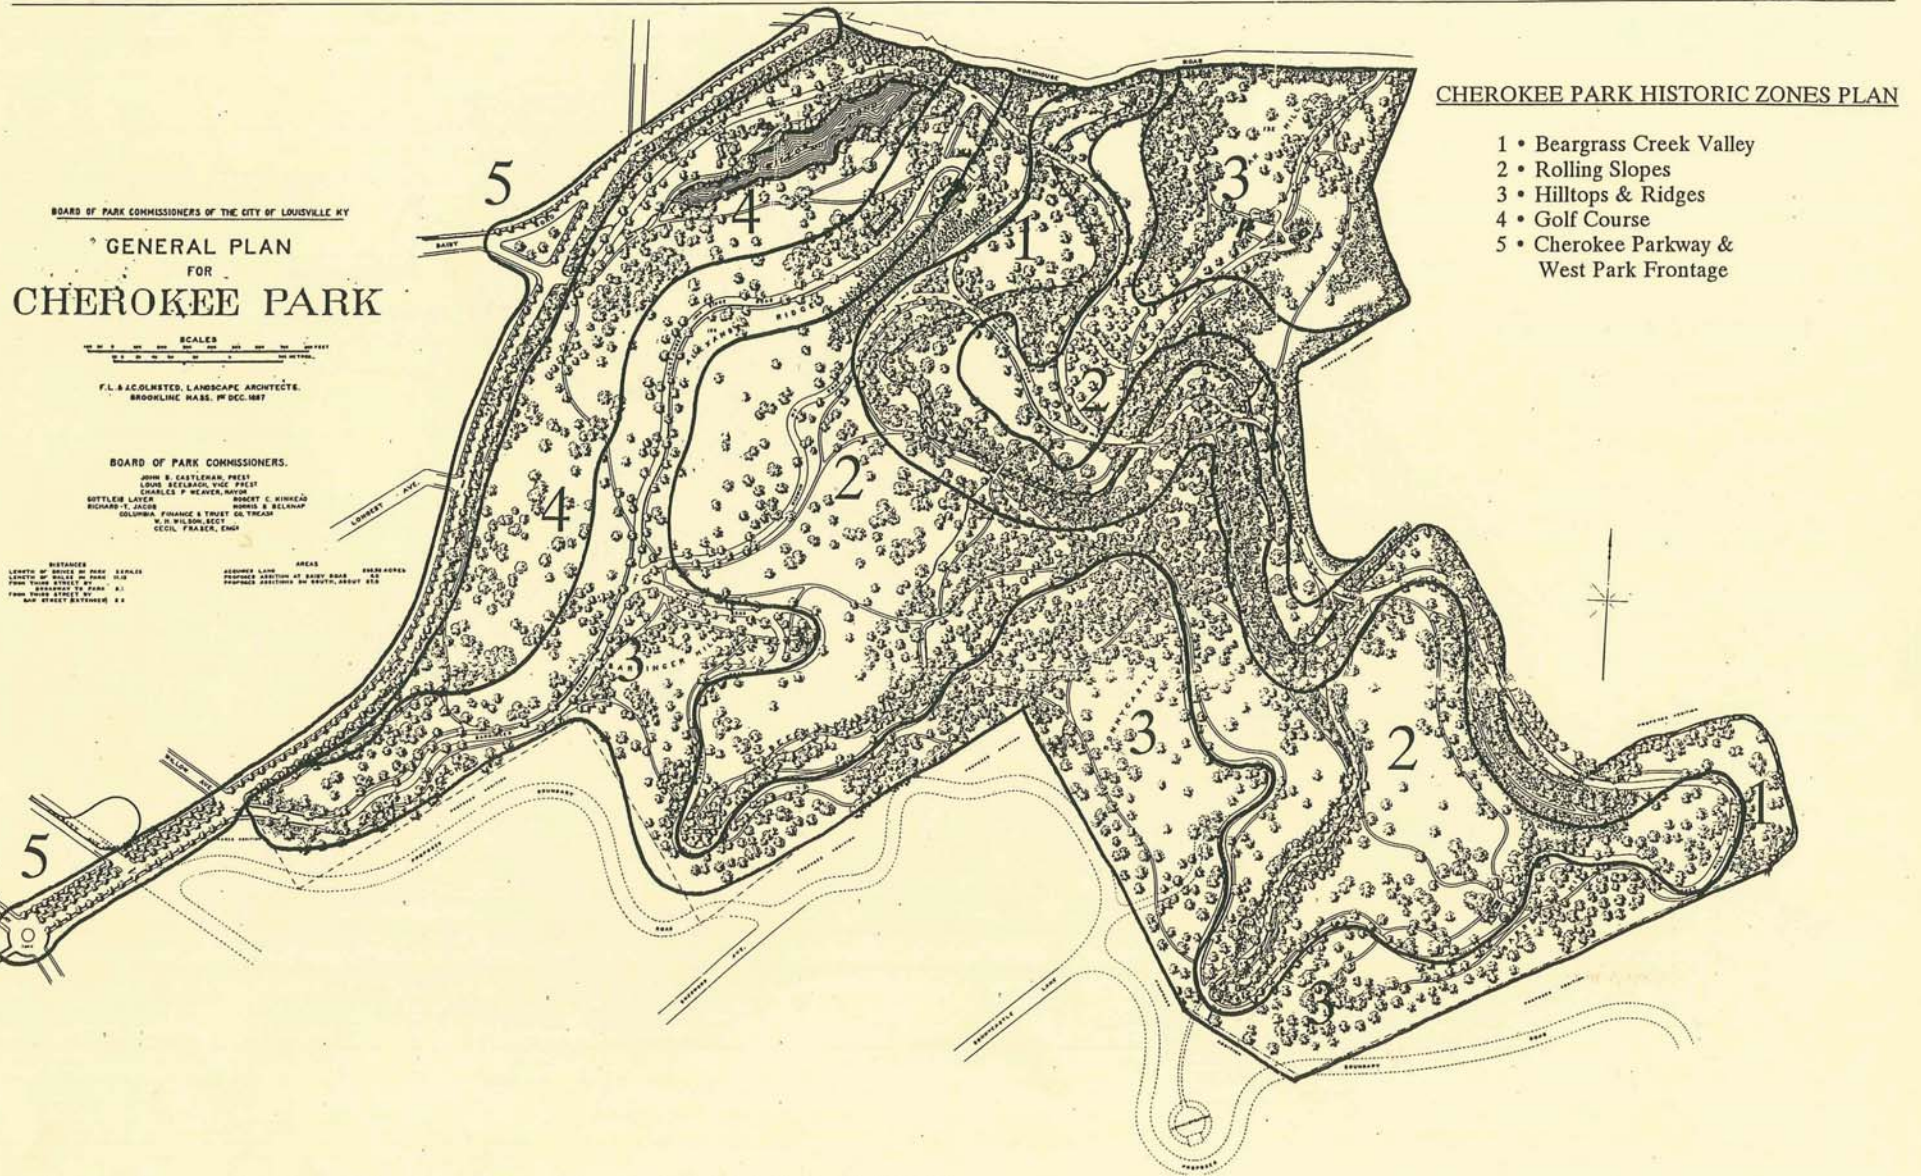
5. Historic Zone Plan, prepared by Landscapes, 1993, overlaid on 1897 General Plan of Cherokee Park, Louisville, Kentucky. (FLONHS)

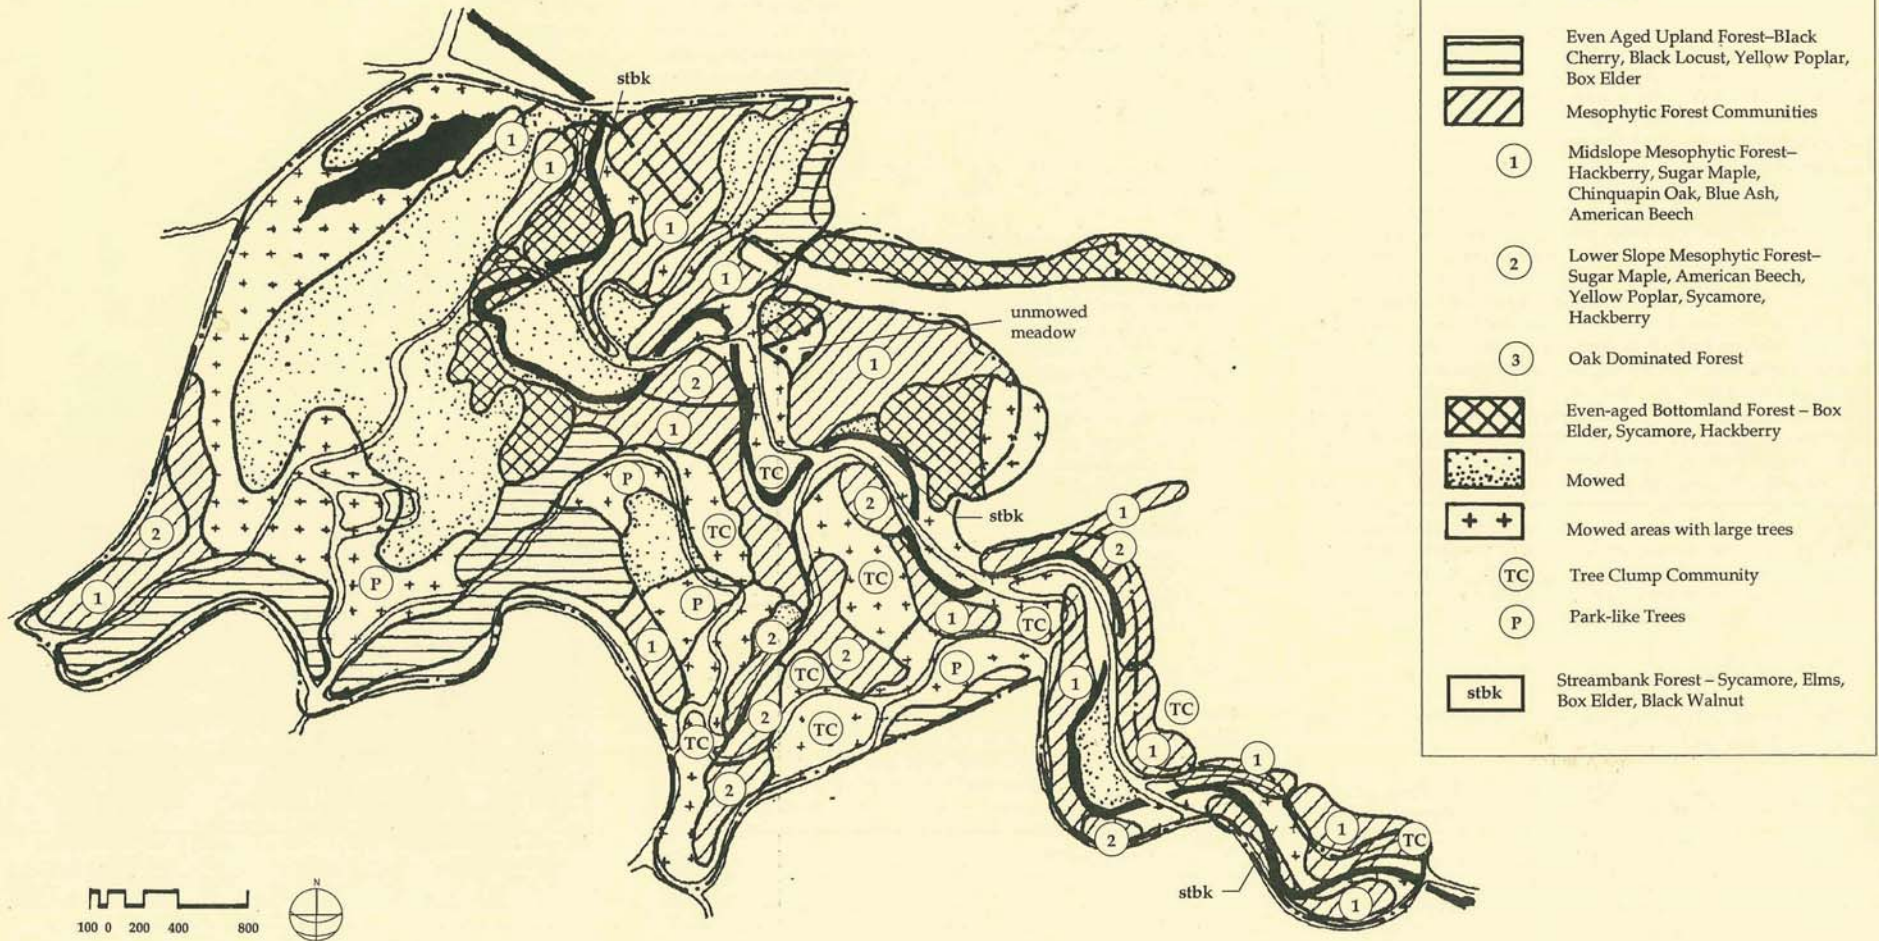
### Cherokee Park: Plant Communities

Prepared by Eco-Tech, Inc., Frankfort KY

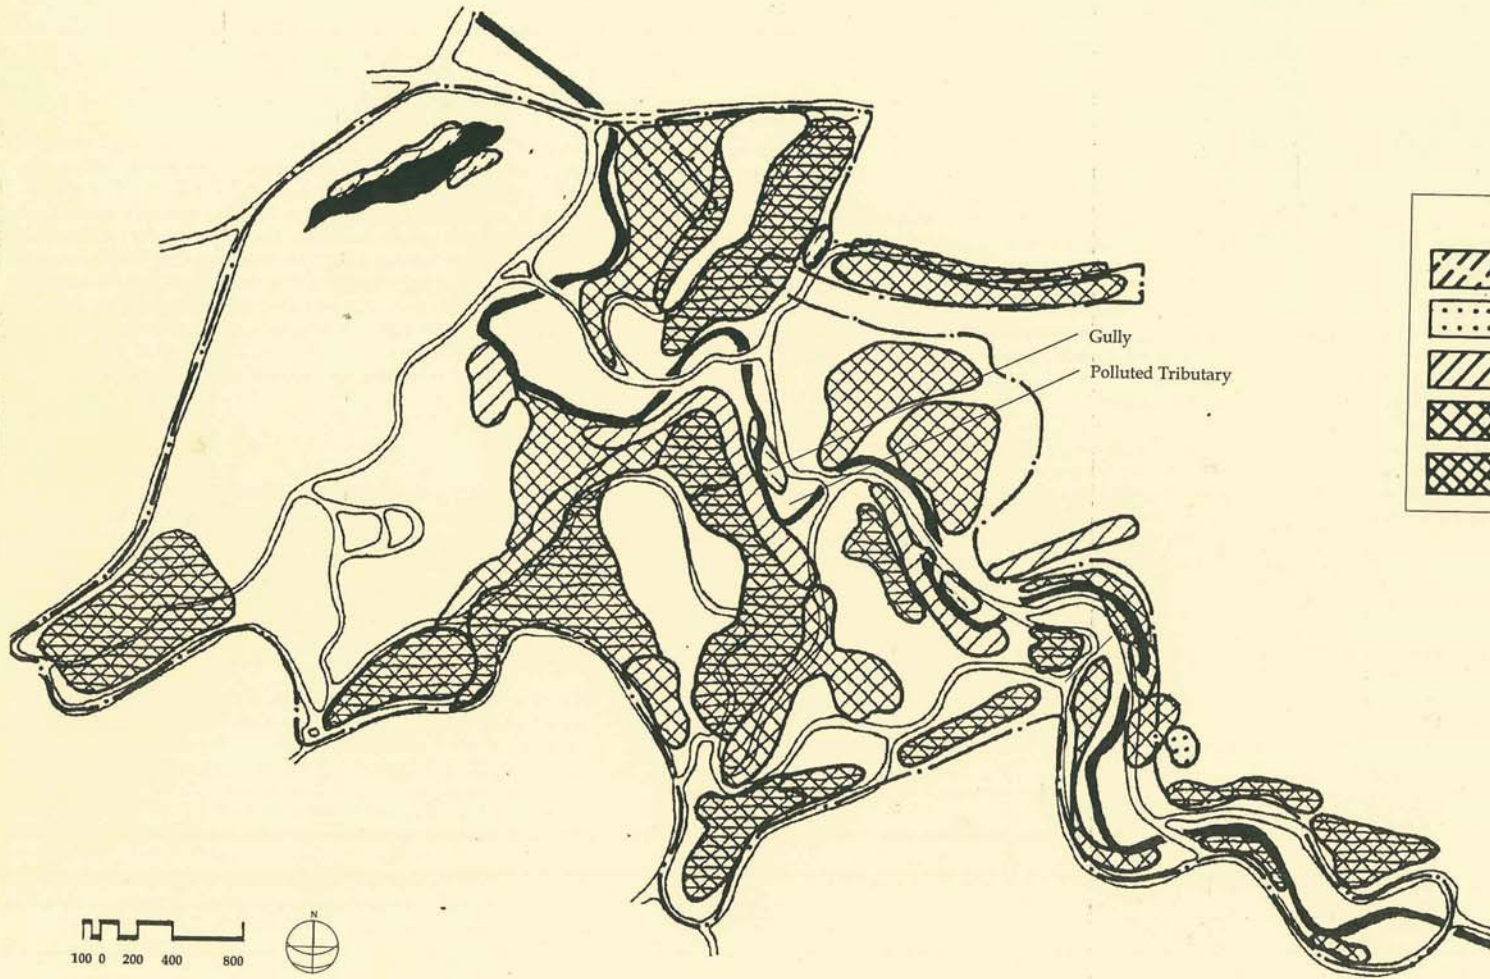
### Cherokee Park: Disturbance

Prepared by Eco-Tech, Inc., Frankfort KY

Although some of the soils on the forested slopes are considered highly erodible, trails are usually only rutted where they proceed directly upslope. Trail bike paths have not caused severe problems, except where they go directly uphill. A few gullies have begun where development or trash piles have increased runoff. Gullies and trail erosion points are marked on the disturbance map. Trails cause more of a problem as an invasion opportunity for the exotics described above.

A few areas are marked on the disturbance map where dumping has occurred within or very near park boundaries. Although unsightly, they also present a more severe problem as an infection point where exotic species can invade into the adjacent forest. Presently, the only place where the exotic biennial herb, garlic mustard (*Alliaria officinalis*) was found in the park is in a dump near the seminary. Garlic mustard can be a very aggressive weed in deciduous woodlands and excludes native wildflowers. A gully also issues from this trash location.

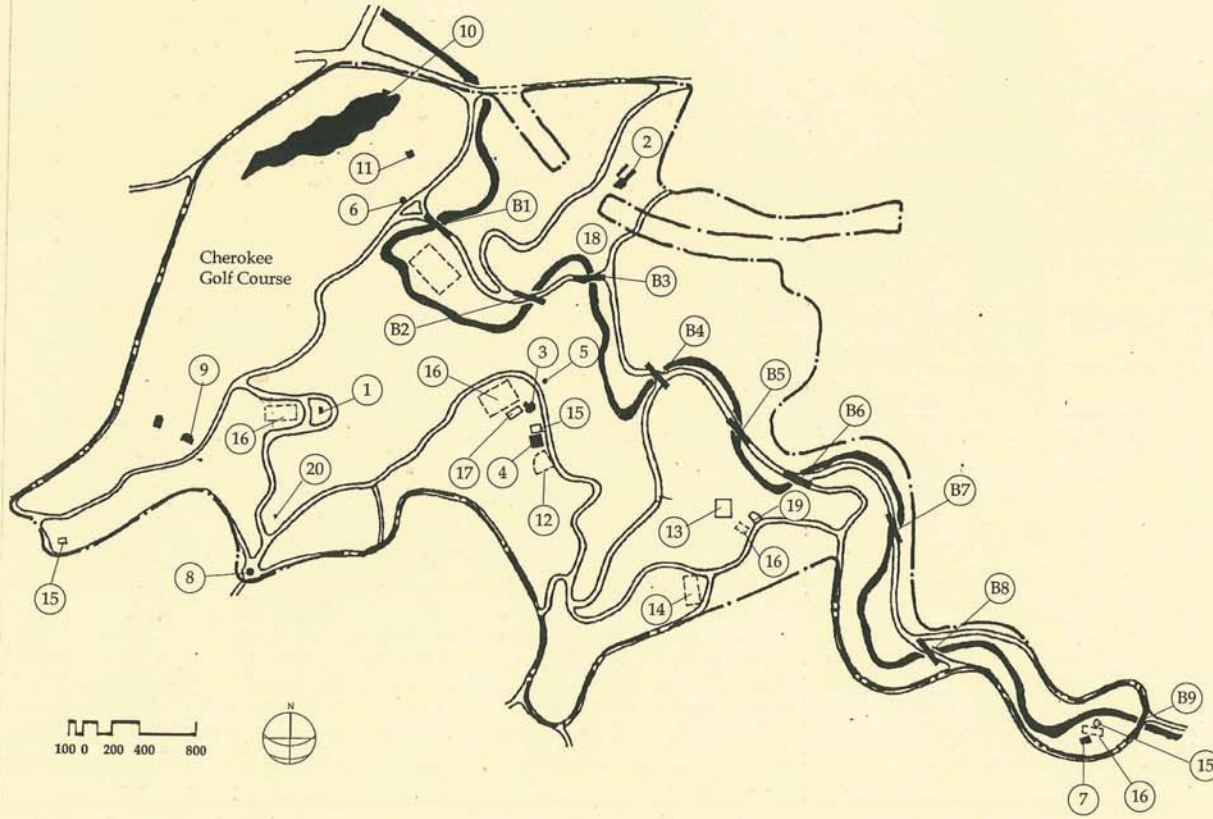
### Cherokee Park: Facilities

Prepared by PDR Engineers, Inc., Louisville KY

There are nine historic bridges along the creek that are adversely affected by frequent flooding. Most of the bridges exhibit some form of deterioration that should be addressed before it becomes unmanageable. Stonework has deteriorated at several of the bridges, especially at Bridge #8.

Three of the nine bridges have been rated substandard by the Department of Transportation and have reduced load ratings. There is strong evidence of scouring under portions of the foundation at Bridge #3, which should be repaired soon. Typically, there is erosion at wingwalls. Most of the bridges appear to bear directly upon rock, and therefore,

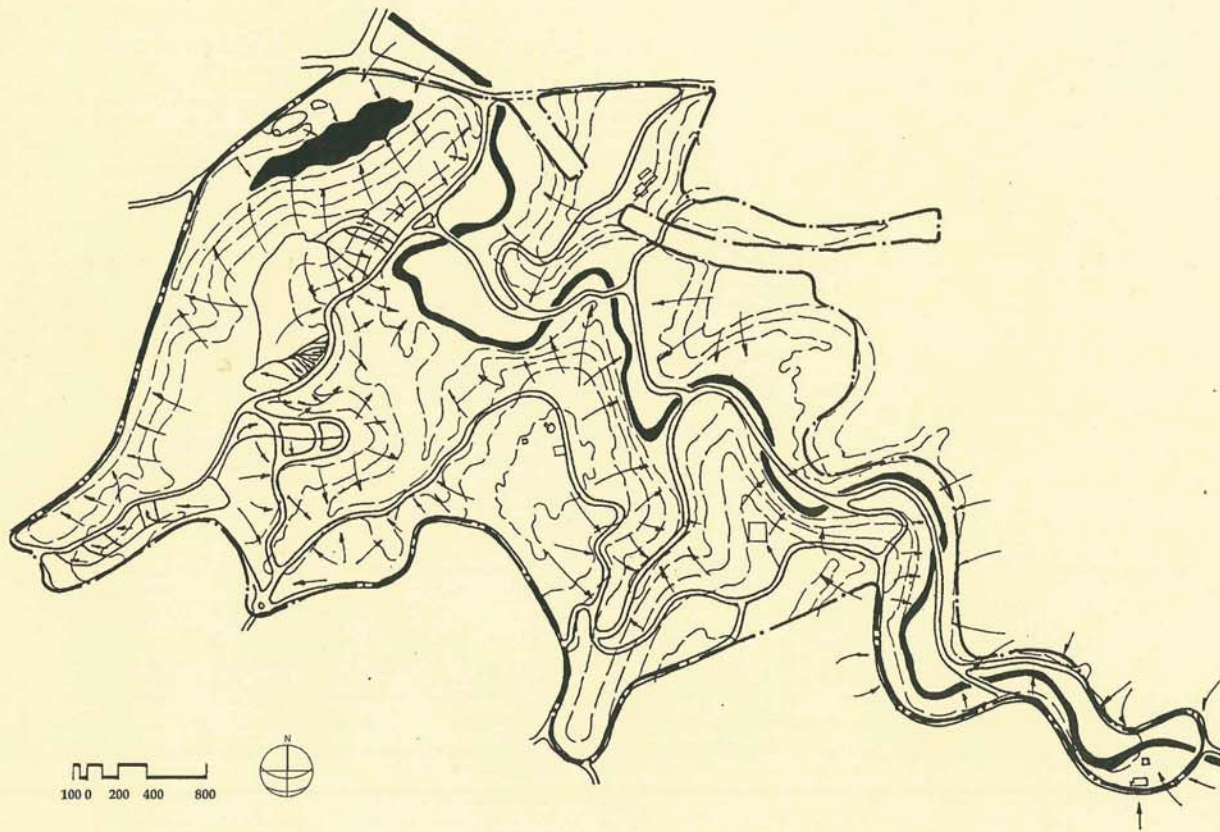
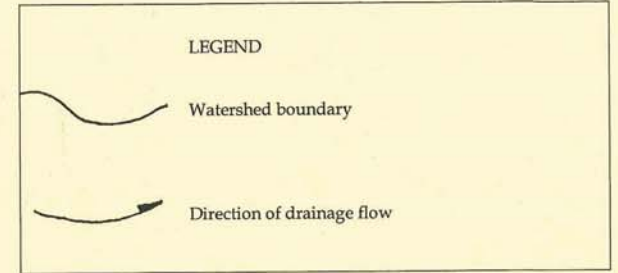
### Cherokee Park: Watersheds

Prepared by PDR Engineers, Inc., Louisville KY
